Maritec Tanker Management

Incident Report's Details

Vessel : Viveka	Defect ID : 171	NCR # : 13/2022	Is NCR ? : Yes
-----------------	-----------------	-----------------	----------------

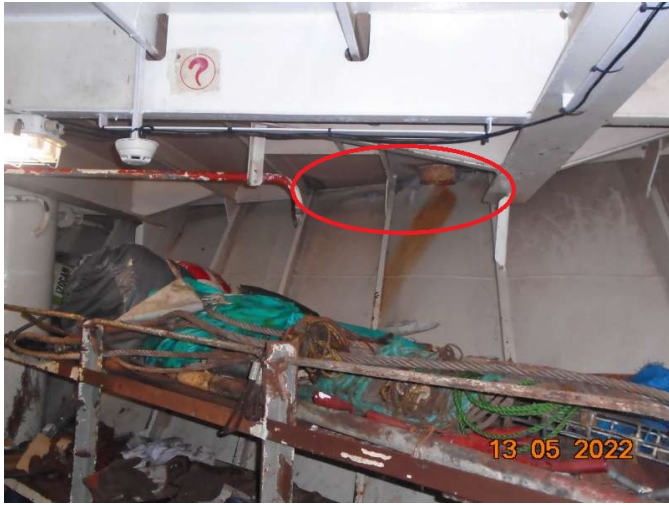
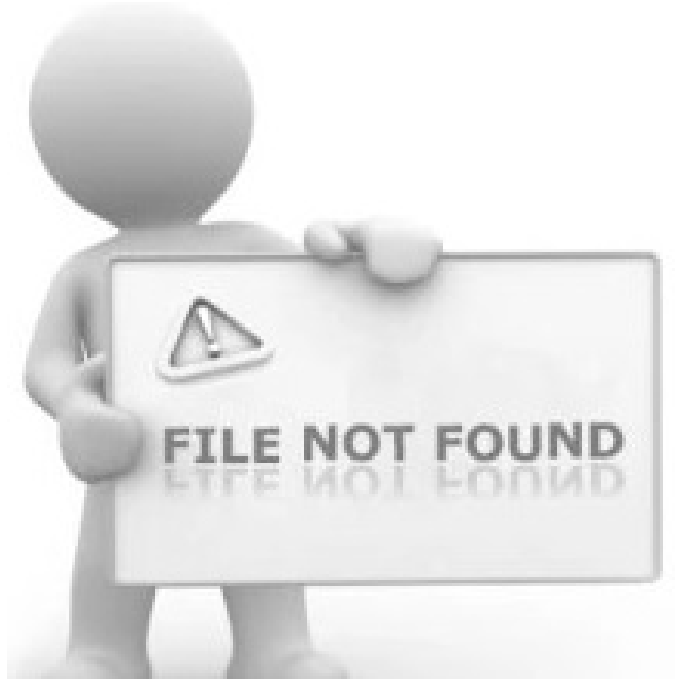
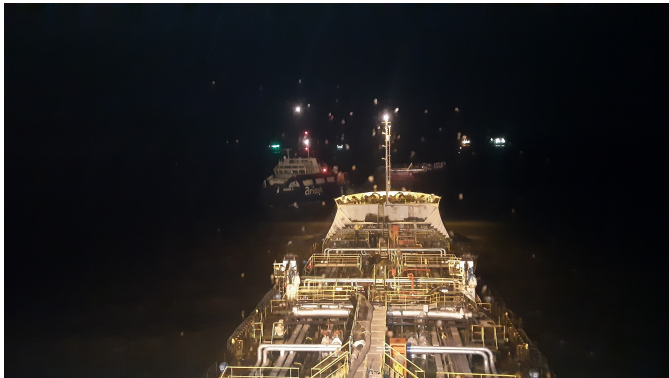
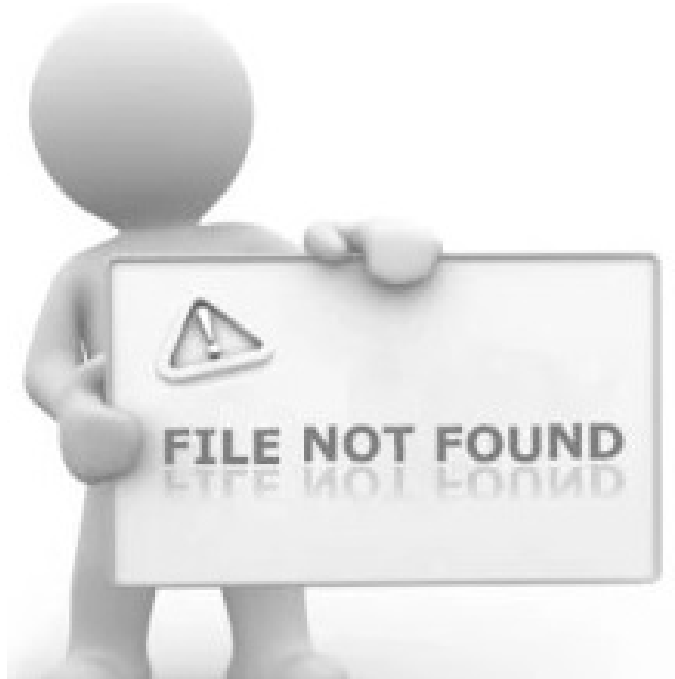
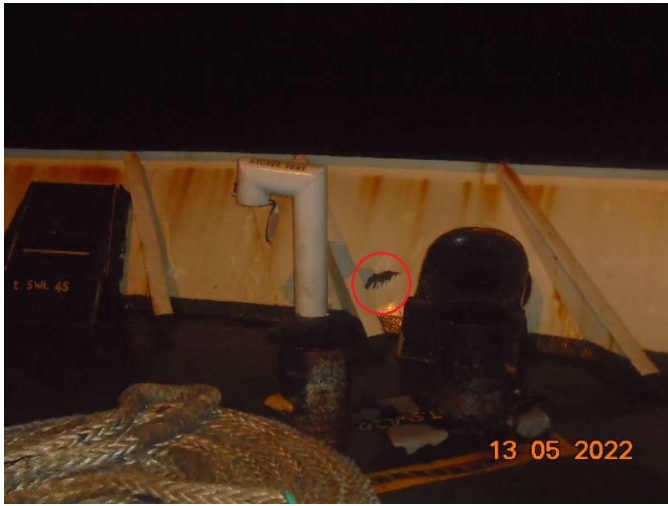
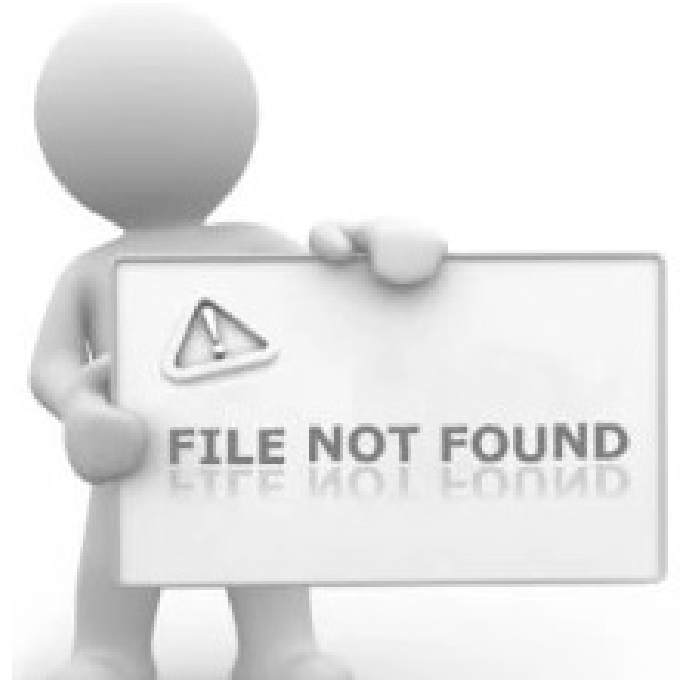
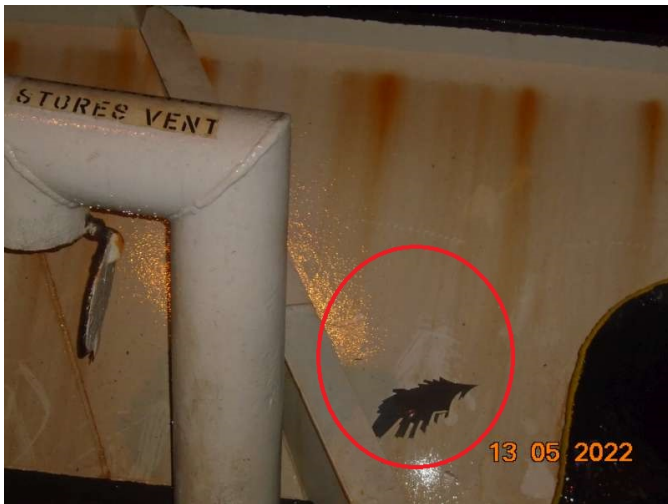
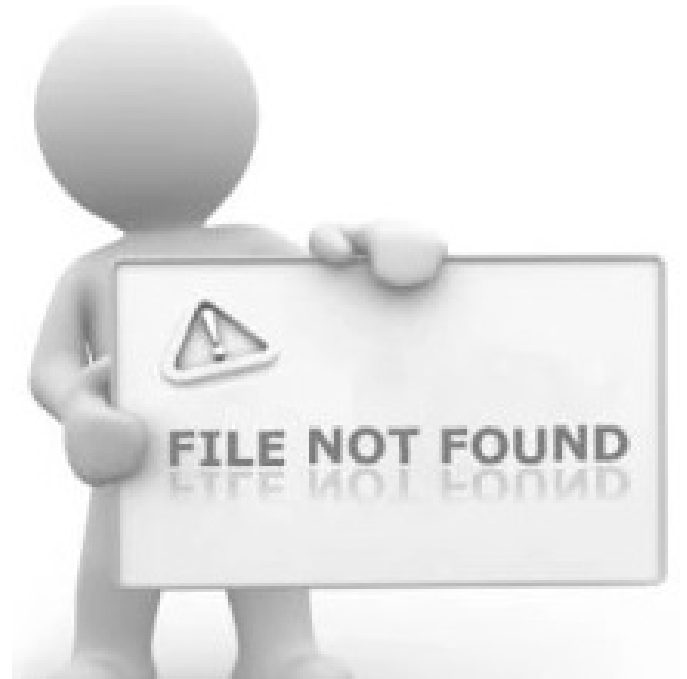
Before & After Pictures

Point of impact by the barge was on our port bow area.

Inspection shows buckling/dent on the bow plating at 3 points. A rupture/crack can be sighted on the shell plating port bow inside the fore peak store between frame 169 to 171 and Buckling of bulwark between frame 172-173 on port bow.

Forepeak tank inspected no visible damage found.

Buckling of the bow shell plate to be straightned
