Near Miss Details

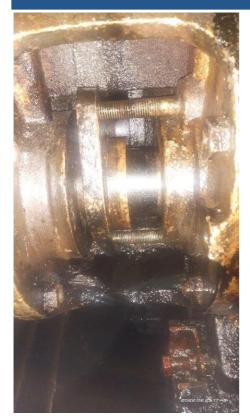
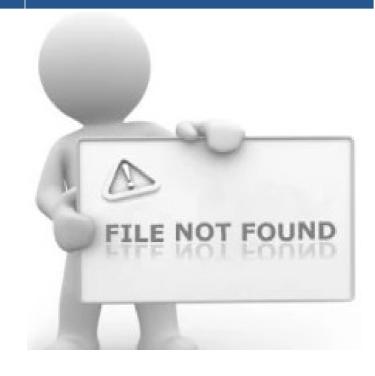
Before

Causes									
Wear and tear									
Corrective Action									
Pump stopped and Gla	nd tightened.	Monitored after st	arting the	pump.					
Preventive Action									
Renewal of gland is planned. During pre operation checks this should be included.									
Applicable Tags									
Descriptions									
Machinery / Equipment Damage									
Root Causes- Job Factor									
Excessive Wear and Tear									
Follow Up

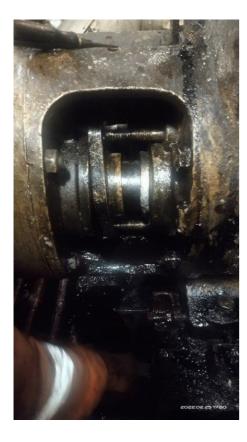
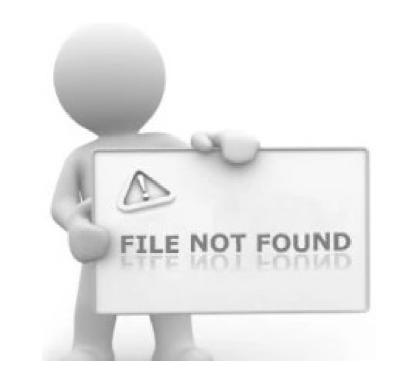
After

On	Ву	Follow Up	
28/Mar/2022	Nagaraju Rayani br/> Staff Code - 10431 - C/OFF	Gland renewed. Pics uplodaed after renewal. Working satisfactory	
03/Mar/2022	Nawin Khaware	Submit evidence/photographs once gland packing has been renewed and tested to be found working satisfactory.
