Maritec Tanker Management Defect List Details

Defect ID: 179 Is NCR?: Yes Vessel: Bahama Blue NCR # : 2/2023

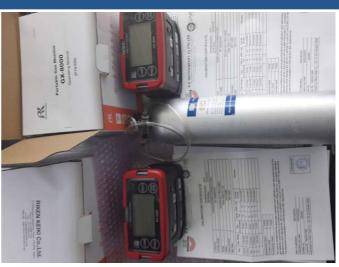
After

During annual inspection US Coastguard made deficiency(PSC Group Code 06105; Action code 17AC): Tankers shall be equipped with at least one portable instrument for measuring Oxygen and one for measuring flammable vapour concentration, together with a sufficient set of spares. Suitable means shall be provided for the calibration of such instruments. The vessel's portable gas detector is not operable and is unable to be calibrated. The vessel also does not have a set of spares.

Unexpected failure of O2 sensor during calibration requested by US Coastguard. Vessel has sent 3 gas meters ashore for annual calibration.
Only 1 pce Altair 5X and 2 pcs Altair 4X on board.
Gas meter Altair 5X failed for calibration and determinated as malfunctioned.

Company provided urgent delivery set of 2 spare gas meters and spangas bottle(ex-Demerara).

On By Follow Up Valentin MITENKOV
Staff Code - 10552 - MST Valentin MITENKOV
Staff Code with span gas for bump test and related fittings are made available onboard. The gas meters were checked to be operational and calibrated with satisfactory results.
