Maritec Tanker Management Defect List Details

Vessel: Bitu Atlantic Defect ID: 154 NCR #: Is NCR ?: No

Defect Details

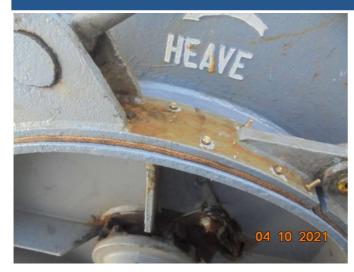
Brake liner of mooring winch forward mooring winch outer drum has been thinned down and requiring replacement. During mooring operation at Tarragona, found mooring brake was holding satisfactorily however it is prudent to get this changed on priority as vessel doing several STS operations at Lome where strain on ropes are likely to be high and the present condition might pose a risk to mooring safety.

Wear and Tear (Not Related to Lack of Maintenance)

On	Ву	Follow Up	
28/Oct/2021	Nawin Khaware	After renewing the brake liner, carry out brake holding test of that winch and upload the test report.	
05/Oct/2021	Nawin Khaware
