Before & After pics

Vessel : Bitu Express
Defect ID : 125
NCR # : 11/2021

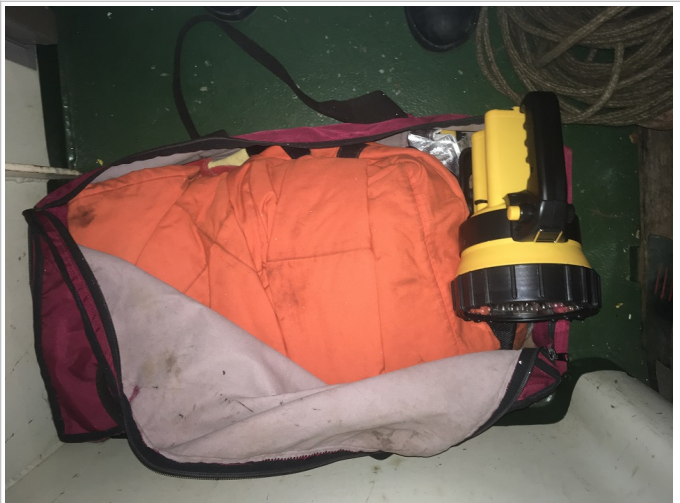
DURING FIRE DRILL ONE FLASHLIGHT FROM FIREMAN'S OUTFIT WAS NOT ILLUMINATING, AFTER CHECKING THIS IS FOUND THAT THE FLASHLIGHT IS NOT RECHARGEABLE. ALL FIREMAN OUTFITS ARE EQUIPED WITH SAME FLASHLIGHTS. AND THERE IS NO FLASHLIGHTS ON BOARD TO BE REPLACED.

Near Miss Description (Please Mention The Event Chronologically)	FIREMAN OUTFIT FLASH LIGHTS		
Department where Near Miss occurred	Deck <input checked="" type="checkbox"/> Navigation <input type="checkbox"/> Engine <input type="checkbox"/>	Galley <input type="checkbox"/>	
Location Of Near Miss (Unsafe Act / Condition) On Ship	Deck <input checked="" type="checkbox"/> Engine Room <input type="checkbox"/> Cargo / Ballast Tank <input type="checkbox"/>		
	Pump room <input type="checkbox"/> Accommodation Spaces <input type="checkbox"/> Galley <input type="checkbox"/>		
Incident Category (Potential)	Engine Room Work Shop <input type="checkbox"/> Stairs <input type="checkbox"/> Others <input type="checkbox"/>		
	Insignificant <input type="checkbox"/> Minor <input type="checkbox"/> Moderate <input checked="" type="checkbox"/>		
Possible Consequence (Can Be More Than One)	Major <input type="checkbox"/> Catastrophic <input type="checkbox"/>

Immediate Corrective Action(s) Taken	TEMPORARY USING DECK FLASH LIGHTS. REQUISITION ISSUED UNDER SAFETY/EMERGENCY PRIORITY.		
Root Cause	PERSONAL FACTORS NOT APPLICABLE		
	JOB FACTORS INADEQUATE / INCORRECT TOOLS AND EQUIPMENT		
Further Proposed Corrective Measures Required	REQUISITION RAISED FOR RECHARGEABLE FLASHLIGHTS. TEMPORARY USING DECK FLASH LIGHTS.

Root Cause Identified After Analysis	FAILURE OF EQUIPMENT
Further Proposed Corrective Measures Required	TEMPORARY USING DECK FLASH LIGHTS. REQUISITION ISSUED UNDER SAFETY/EMERGENCY PRIORITY.
Responsible Person For Closure On Board	Master / Chief Officer / 2nd officer / 3rd Officer / Chief Engr / 2nd Engr / Electrical Officer (Circle appropriate and Strike Out rest all)
Responsible Person For Closure in Office	Tech Manager / Marine Operations / QHSE / CSO / Purchasing (Circle appropriate and Strike Out rest all)
Time Limit for Corrective Actions	15 DAYS
