Maritec Tanker Management Private Limited

Incident Reports Details

Vessel : Asphalt Teranga	Defect ID : 184	NCR # : 26/2023	Is NCR ? : Yes
--------------------------	-----------------	-----------------	----------------

Grounding

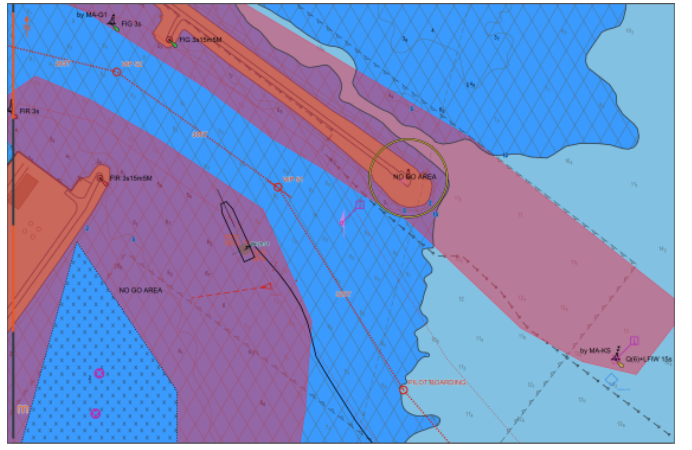
Before & After Pictures

4. Improper monitoring of passage & Lack of situational awareness. Due strong wind and heavy swell she was continuously setting towards shallow patch and finally she ran aground on her port bow area.

1. Vessel tried to refloat by giving astern movement on engine however failed so requested with port for the assistance of two strong tug to pull her out from grounded position.
2. Vessel refloat with the help of 02 tugs and maneuvered safely to the berth.
3. Diving Team were arranged for carrying out underwater inspection to assess the damages.
