Maritec Tanker Management Incident Reports Details

Vessel: Bitu Atlantic Defect ID: 264 NCR #: 3/2023 Is NCR ?: Yes

Defect Details

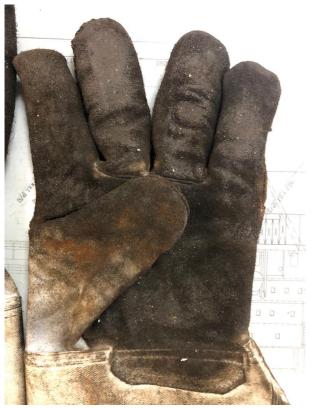
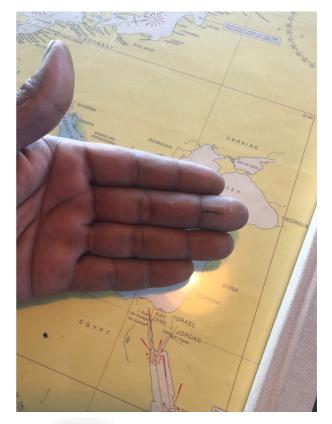
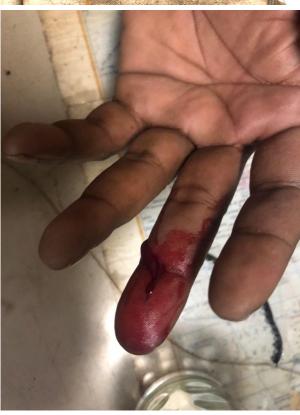
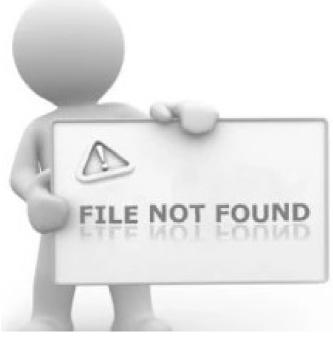
Fitter Mr.Acchelal while removing spool piece from the Scrubber sea water line, the Spool piece fall on his left hand middle finger and injured with small cut.

Uncoordination of workers during the job

Work was stopped immediately, first aid was given to the person involved.

Retraining to be carried out, the job must supervise by engineers
