## **Maritec Tanker Management**

## **Incident Reports Details**

Vessel: Asphalt Teranga Defect ID: NCR #: 16/2023 Is NCR?: Yes

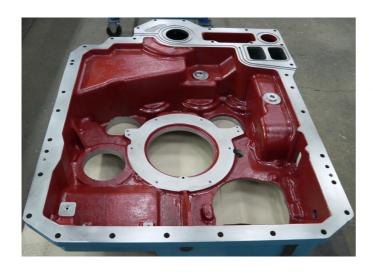
## After

We have issue with HT Water pressure lost of Main Engine. During investigation we have found the attach pump got failure. Dismantle the pump for inspection and found the pump drive gear shaft worn out and gear got damaged. After open the crankcase inspection door, found water leaking from top of HT pump drive gear. Remove the blank and found very big hole on HT manifold.

Mechanical Failure - Equipment breakdown - HT pump drive shaft and gear damaged
