# Maritec Tanker Management Private Limited

## Non Conformance Details

Vessel : Bitu Express	Defect ID : 339	NCR # : 4/2024	Is NCR ? : Yes
-----------------------	-----------------	----------------	----------------

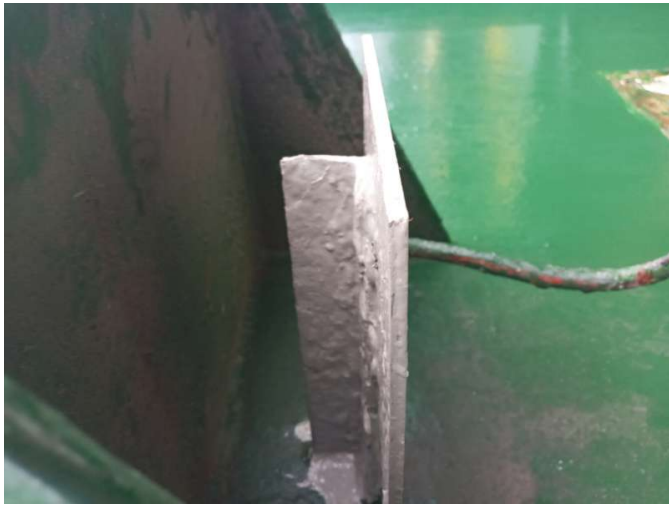
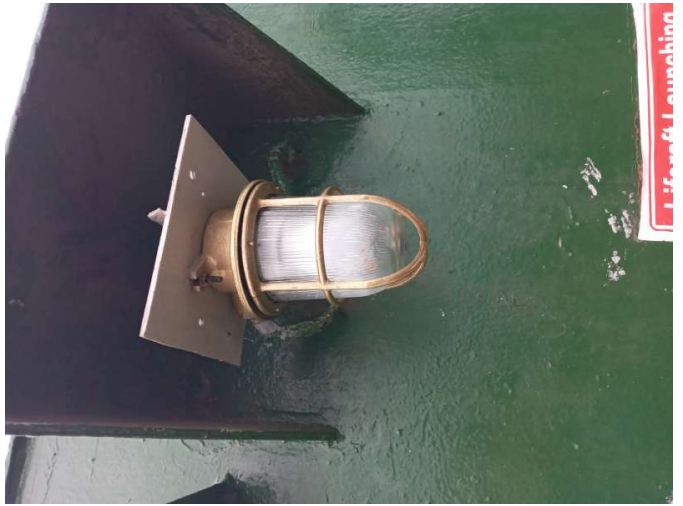
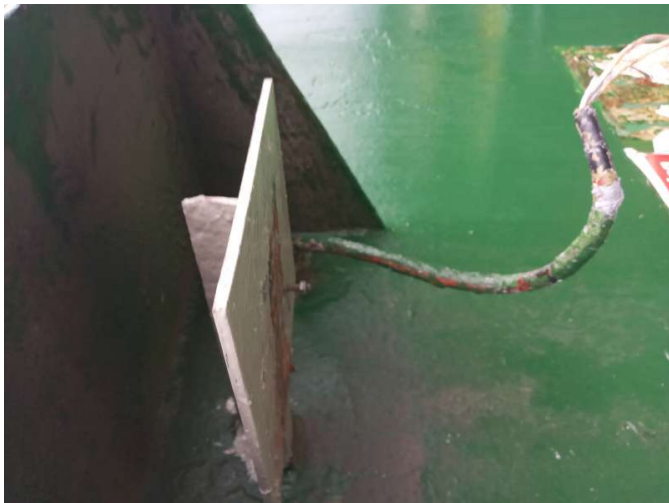
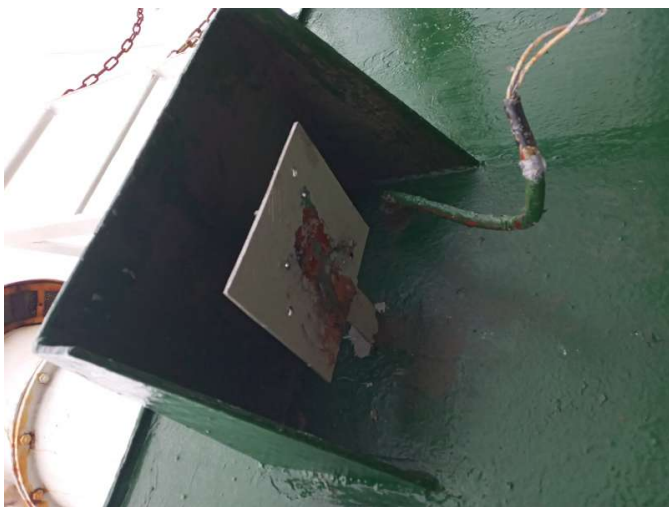
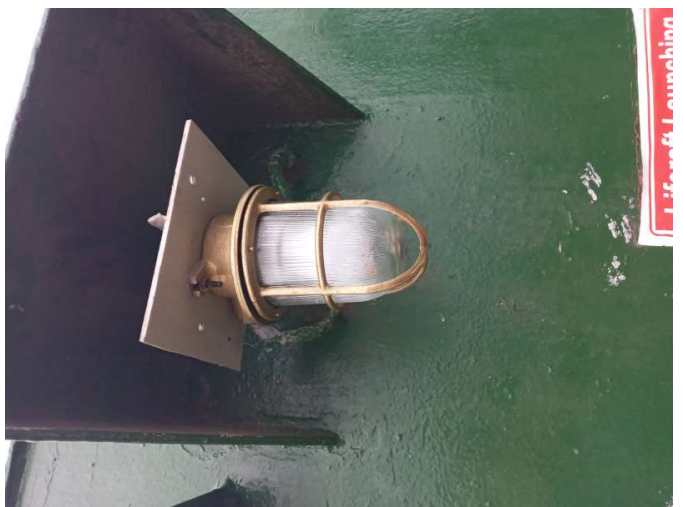
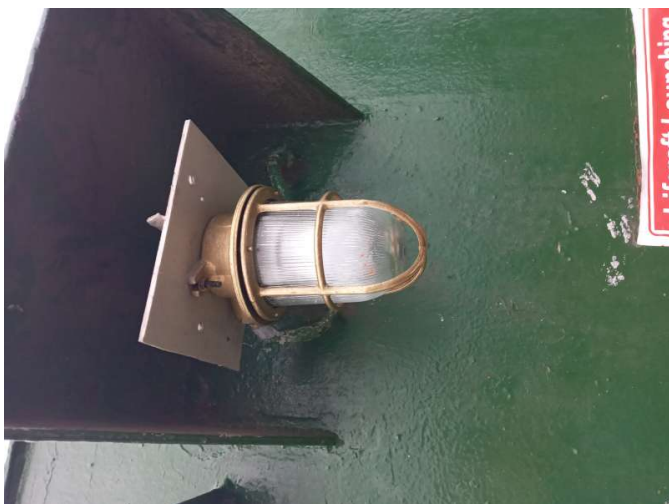
The condition of the ship & it's equipments shall be maintained to conform to the provisions of present regulations to ensure ships in all respect proceed to sea without any danger to ship or it's persons onboard. PSCO observed emergency light above forward liferaft had been broken off dedicated bracket and being held on with nylon rope. Vessel must install the fixed bracket at the first ballast voyage after completion of discharge at US ports.

Lack of routine maintenance for LSA/FFA items, General wear & tier due ageing.

On	By	Follow Up	
05/Apr/2024	Marin Panait   Staff Code - 10017 - MST	Vessel in ballast cond from 03-04-2024, Office informed, HWP in place for this date, welded accordingly new support, replace the lights with new one.	<a href="#">Link1</a> <a href="#">Link2</a> <a href="#">Link3</a> <a href="#">Link4</a>
31/Mar/2024	Marin Panait   Staff Code - 10017 - MST	Identified during PSC inspection, vessel check the possibility to solve. As the vessel ins in loaded condition, and for rectified this observation need HW permit, vessel request to postpone the job till ballast passage ( aprox 3rd April 2024 ), when the vessel can obtain HW permit. Checked on board, vessel have materials to fabricate new support and also have new spare emergency light.	<a href="#">Link1</a> <a href="#">Link2</a> <a href="#">Link3</a> <a href="#">Link4</a> <a href="#">Link5</a> <a href="#">Link6</a> <a href="#">Link7</a> <a href="#">Link8</a>
