Maritec Tanker Management Private Limited

Near Miss Details

Vessel : Bitu River

Defect ID : 57

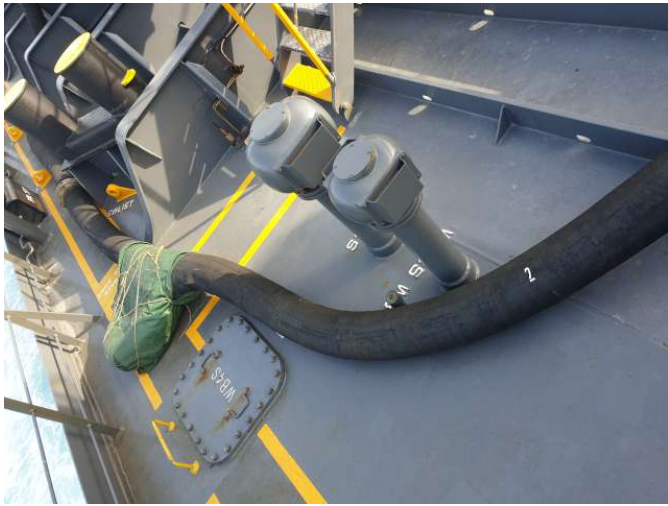
During air blow of shore line by terminal staff, shore valve wasn't closed and a sudden raise of pressure surge on ship's cargo hose which damaged the hose outer rubber protection .Inner steel cargo hose remain intact ,otherwise a cargo spill was inevitable.

Improper communication between ship's staff and terminal staff.
Cargo hose poor quality.The test certificate for the hose state that hose was tested at 24 bars
