# Maritec Tanker Management Private Limited

## Incident Reports Details

Vessel : Asphalt Teranga	Defect ID : 198	NCR # : 40/2023	Is NCR ? : Yes
--------------------------	-----------------	-----------------	----------------

**DIVER'S REPORT:  
 IN-WATER SURVEY**

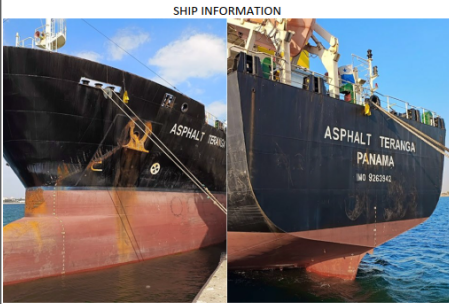
**SHIP INFORMATION**

NAME	ASPHALT TERANGA
IMO NUMBER	9263942
FLAG / HOMEPORT	PANAMA / PANAMA
LENGTH	108.5 M
BREADTH	19.80 M
DEPTH	10.6 M
TYPE	ASPHALT TANKER
