Maritec Tanker Management

Incident Report's Details

Vessel : Bitu Atlantic	Defect ID : 254	NCR # :	Is NCR ? : No
------------------------	-----------------	---------	---------------

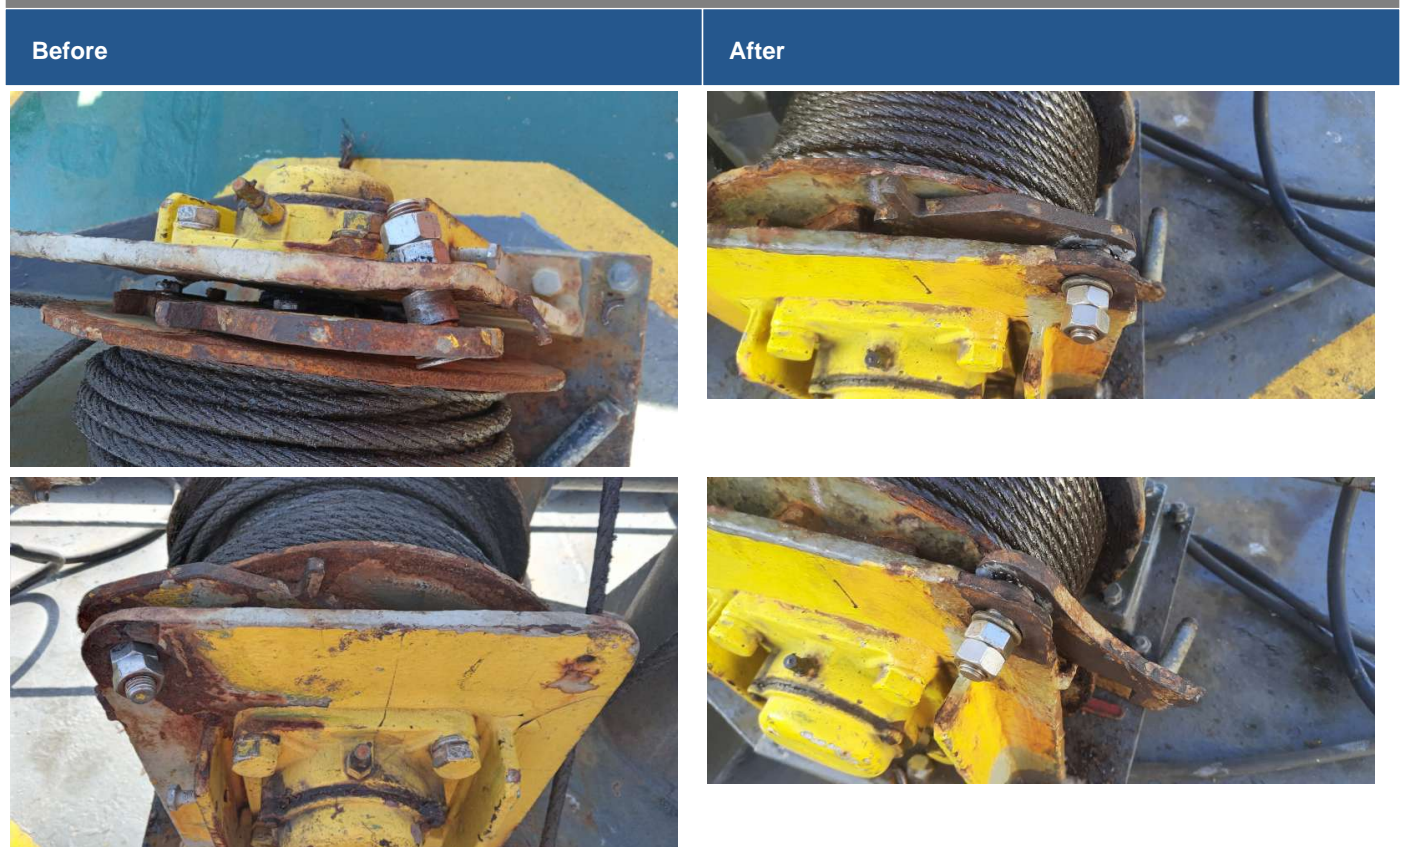
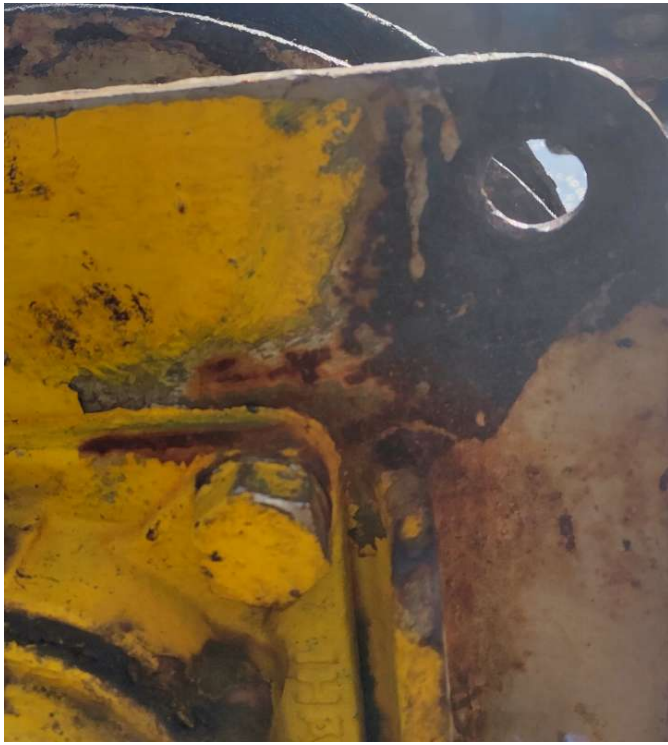
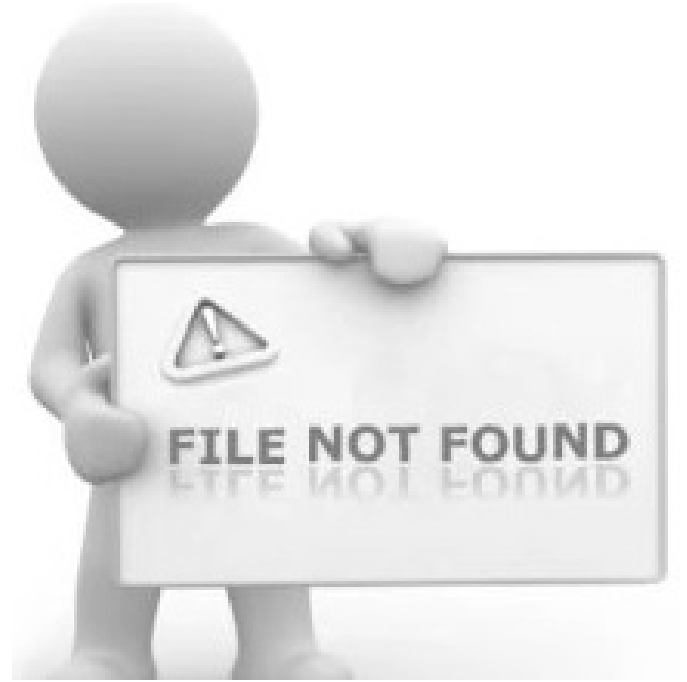
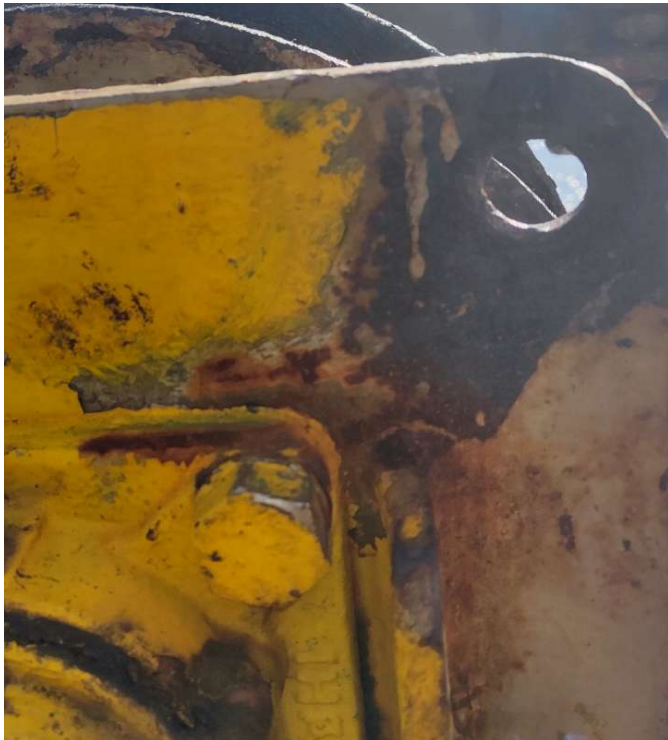
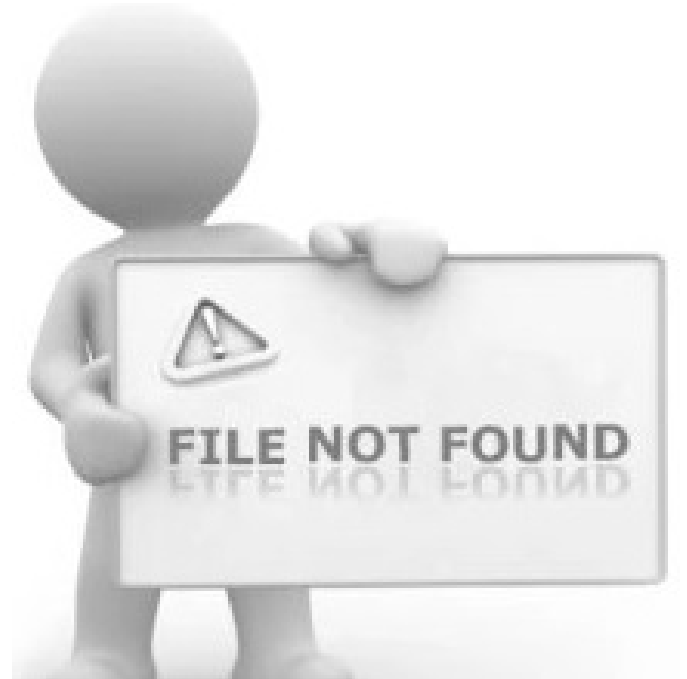
Before & After Pictures

Date : 07-11-22
Time : 0300 LT
Place : Off Las palmas pilot station
During preparation of port Combination ladder for pilot. The Gangway falls in uncontrolled manner in water and the wire parted. The gangway is fully recovered on board and stowed back in the position with the help of the crane.
No any visual damage found to the gangway.
Investigation revealed that ratchet lock jumps from the drum due to wear and tear of the ratchet locking arrangement.

Excessive wear and tear.
Situational awareness.

Rectification of the Ratchet locking arrangement.

On	By	Follow Up	
01/Dec/2022	Nawin Khaware	Basis submitted evidence, this report could be considered as closed out now.	
14/Nov/2022	Vivek Kashyap Staff Code - 10239 - MST	Port gangway wire renewed on 11-Nov-2022	
14/Nov/2022	Vivek Kashyap Staff Code - 10239 - MST	Ratchet locking arrangement for both the side rectified.	
14/Nov/2022	Vivek Kashyap Staff Code - 10239 - MST	Port gangway renewed on 11-Nov-2022.	
14/Nov/2022	Vivek Kashyap Staff Code - 10239 - MST	Investigation revealed that Ratchet lock jumps from the drum due to excessive wear and tear of the ratchet lock. Same to be rectified for port gangway and checked for the stbd gangway also.
