Maritec Tanker Management

Incident Reports Details

Vessel : Bitu Atlantic	Defect ID : 263	NCR # : 2/2023	Is NCR ? : Yes
------------------------	-----------------	----------------	----------------

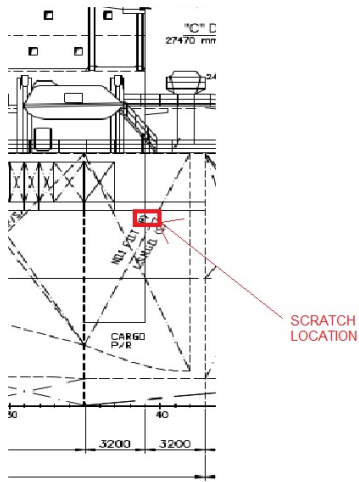
Before	After
--------	-------

DURING THE DEPARTURE MANEUVER FROM END OF STS OPS, THE SHIP MT"XING HAI WAN" AS THE DAUGHTER VESSEL,PERFORMED THE WRONG MANEUVER SO FAST IT TOUCHED THE BODY OF OUR SHIP MT"BITU ATLANTIC" AS THE MOTHER VESSEL

On	By	Follow Up	
20/Jan/2023	Gelu Antin Staff Code - 10124 - MST	LoP issued & sent , Incident Report raised	Link1
20/Jan/2023	Gelu Antin Staff Code - 10124 - MST	CONTACT LOCATION INSPECTED , NO ANY BEND , ONLY A SCRATCH @ 40CM ON STARTBOARD SIDE BELOW LIFEBOAT BETWEEN FRAME 38-40, BELOW MAIN DECK @ 2.5 M	Link1
20/Jan/2023	Gelu Antin Staff Code - 10124 - MST	COMPANY ADPA WAS INFORMED IMMEDIATELY	Link1

STS CL TO BE CARRIED OUT PROPERLY

PROPER COMMUNICATION BETWEEN VESSELS
