Maritec Tanker Management

Incident Reports Details

Vessel : Bahama Blue	Defect ID : 183	NCR # : 5/2023	Is NCR ? : Yes
----------------------	-----------------	----------------	----------------

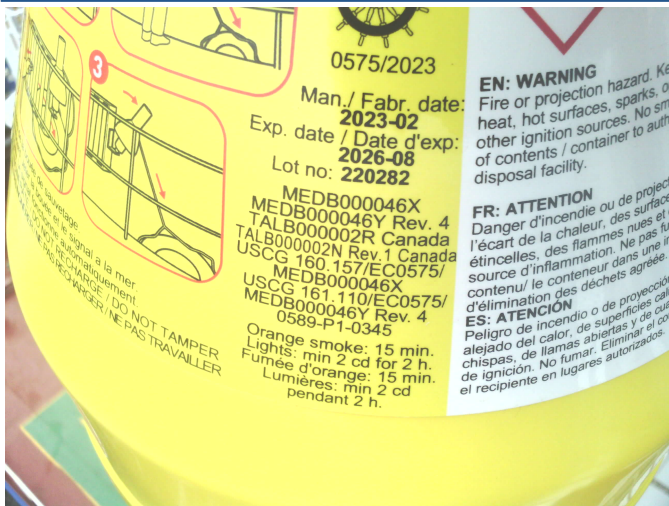
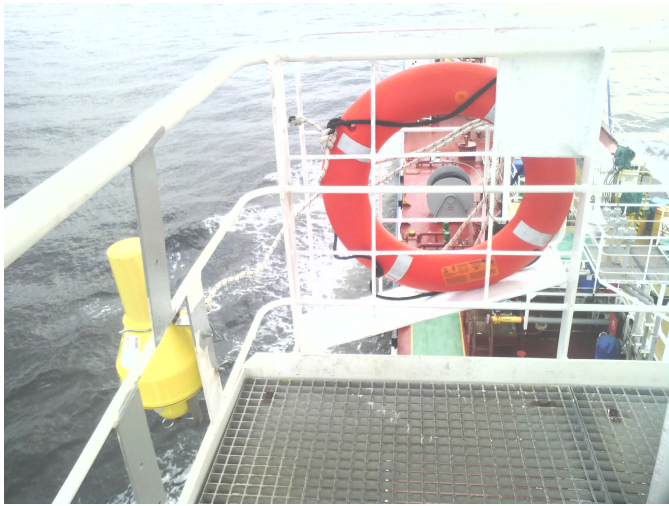
Before	After
--------	-------

During preparation for vetting inspection we made familiarization and training for crew. This happen that MOB buoy Light and Smoke signal(Port side) was occasionally released and activated during demonstration of procedure.

Human factor - wrong action.

Vessel raised urgent requisition BBLU-SF-V230085 - MOB buoy Light and Smoke signal and send to Purchase department. Temporarily instruction posted to use Starboard side MOB Smoke&Light signal buoy.

Extra training for all crew to use ship's Pyrotechnics.
