Maritec Tanker Management

Incident Report's Details

Vessel : Bitu Express	Defect ID : 174	NCR # : 14/2021	Is NCR ? : Yes
-----------------------	-----------------	-----------------	----------------

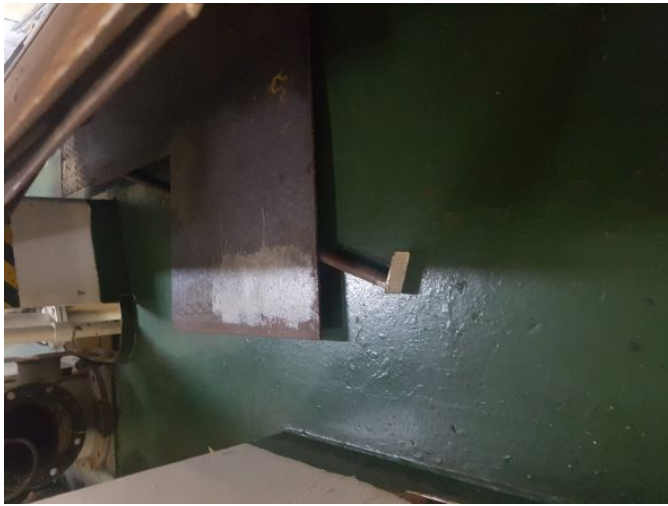
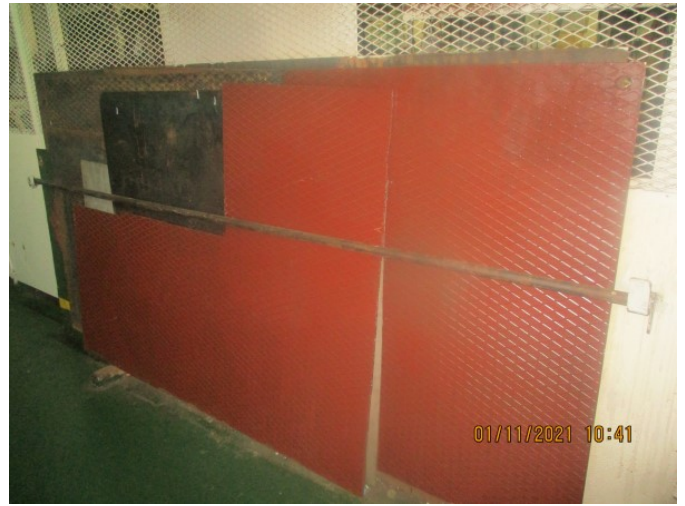
Before	After
--------	-------

RT Fitter was handling alone heavy metal plates in engine room. He unsecured it and then the plates got mishandled due to vessel pitching and rolling in bad weather condition. The plates came over him on his left abdominal area and he was caught between some vertical fixed pipes and plates. As a result, he got scratch marks on his left abdomen. His entire abdominal area is paining all around. Right now he is kept laying in the hospital bed because he can not move easily due to those abdominal severe pain. He has some breaking sensation around abdominal back side area.

Inadequate Work Standards; Adverse Sea / Weather Conditions. Root cause analysis : 1. Improper work supervision - Work was supervised by a senior officer. Job hazard analysis and Risk assessment was not done properly failing which vessel could not implement proper mitigation measures. 2. Complacency - With E/R colleagues we were made aware that Fitter Pradeep got a habit of working all alone without asking for any extra hands though type of jobs might require extra hands to complete the task safely. Fitter Pradeep likes to work alone most of the time and so his supervisor fails to ascertain the risk associated with "Lone Workers". 3. Bad weather - Bad weather lead to rolling causing plates to ship with greater force which went uncontrolled and hit the abdominal area of Fitter Pradeep & finally he got injured as was stuck between the plates and the vertical pipe.

Follow proper works standards; The plates were stored back and secured properly; Job was cancelled.

Carry out a Proper work Planning, Follow up the work with Monitoring & adequate Supervision.
