Maritec Tanker Management Private Limited

Non Conformance Details

Vessel : Bitu Express	Defect ID : 340	NCR # : 5/2024	Is NCR ? : Yes
-----------------------	-----------------	----------------	----------------

Hole Observed on PV Valve Mesh 2 Stbd During PSC Inspection

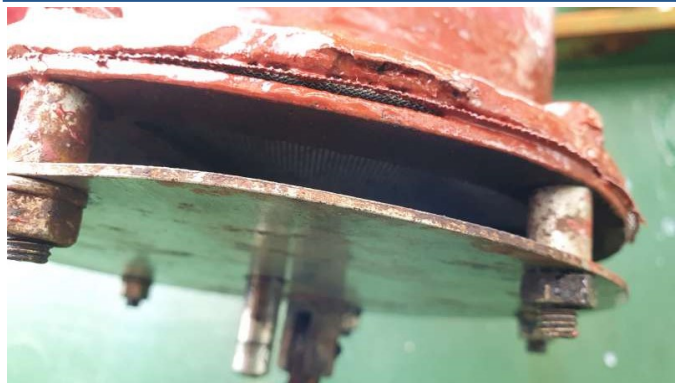
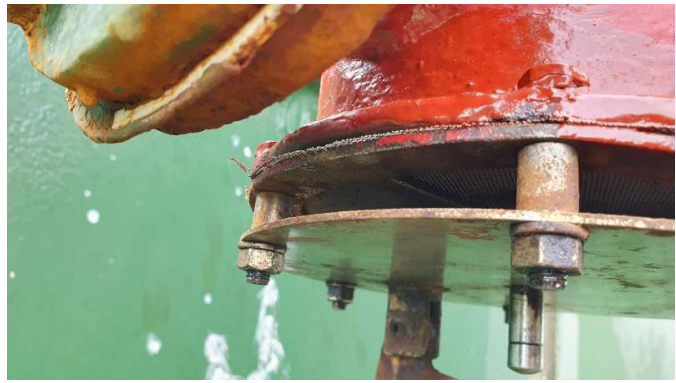
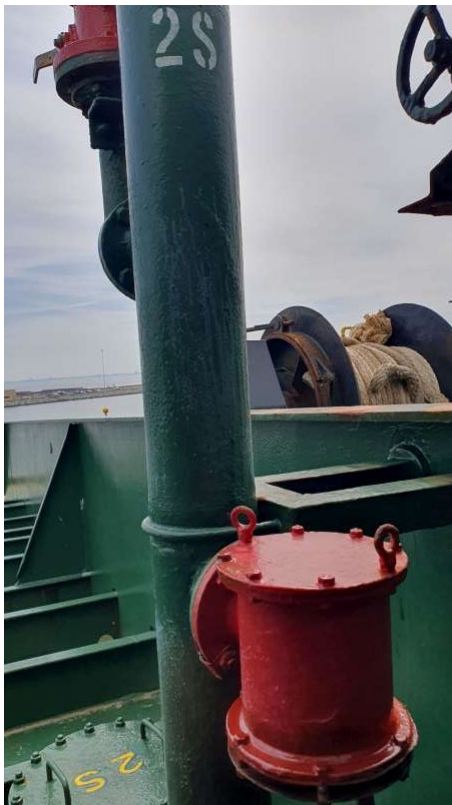
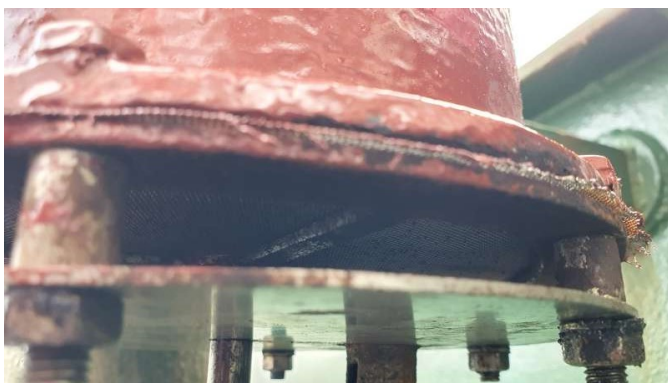
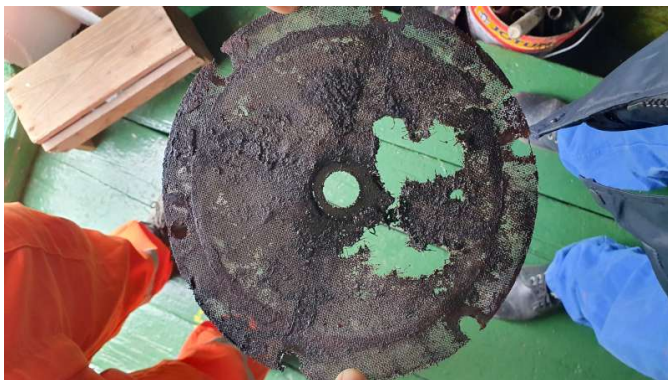
Before & After Pictures

General wear & tier. Lack of supervision.

PV valve wire mesh for 2 (S) COT has been renewed in front of Inspector.

PMS routines for all PV Valve for integrity of wire mash to be carried out regularly. Operation of PV valves must be tested prior each operation.
