Maritec Tanker Management Private Limited

Non Conformance Details

Vessel : Bitu Express	Defect ID : 338	NCR # : 3/2024	Is NCR ? : Yes
-----------------------	-----------------	----------------	----------------

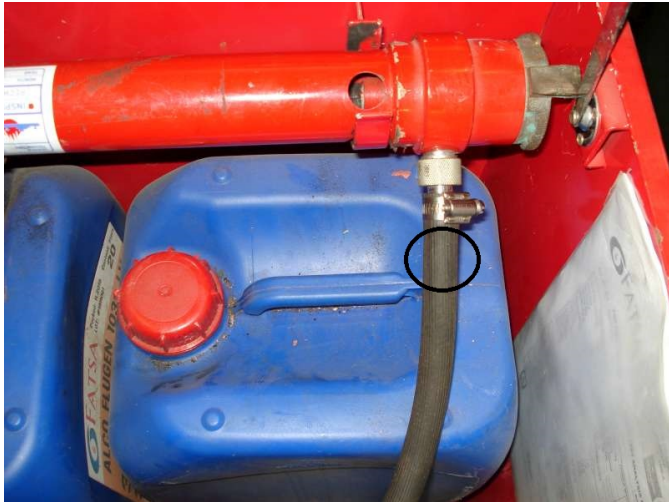
Before & After Pictures

There should be atleast pne portable foam applicator unit complying with the provision of FSS code. USCG Inspector found that hose on eductor drive was rusted & torn. This item was replaced immediately once pointed out by the Inspector.

PMS routine not followed diligently, Lack of supervision while maintaining FFA items.

Damaged section was rectified immediately and repaired hoses was kept in place.

PMS routines for safety items must be completed with great care. Safety officer must take regular safety rounds to ensure all LSA/FFA equipments are maintained in good order and in the state of readiness all the time.
