## Maritec Tanker Management

### Near Miss Details

Vessel : Biskra

Defect ID : 67

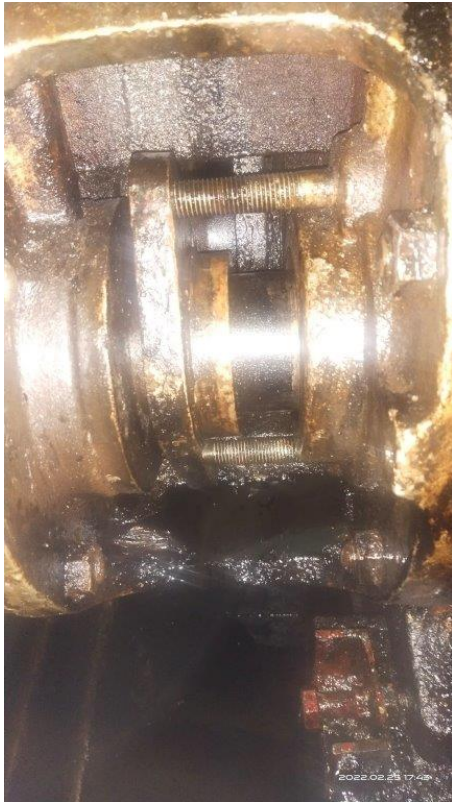
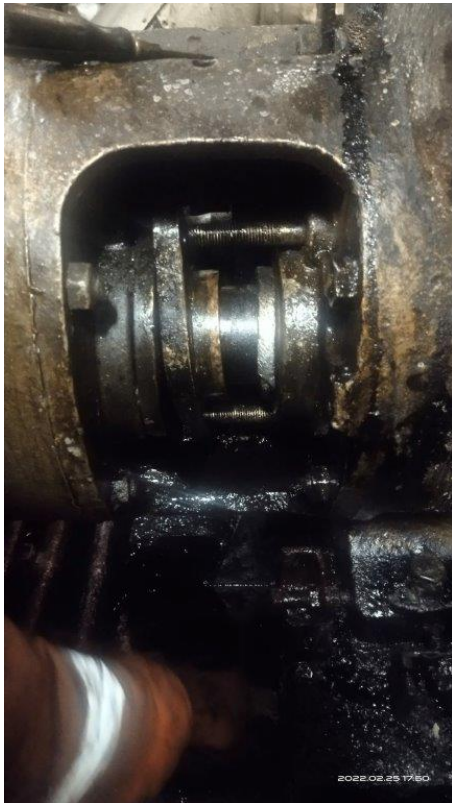
During commencement of Discharge No.4 COP gland found leaking

Wear and tear

Excessive Wear and Tear

Pump stopped and Gland tightened. Monitored after starting the pump.

Renewal of gland is planned. During pre operation checks this should be included.
