Maritec Tanker Management

Near Miss Details

Vessel: Biskra Defect ID: 67

During commencement of Dischrage No.4 COP gland found leaking

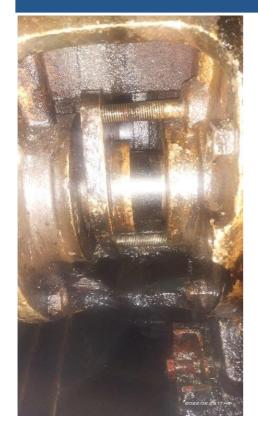
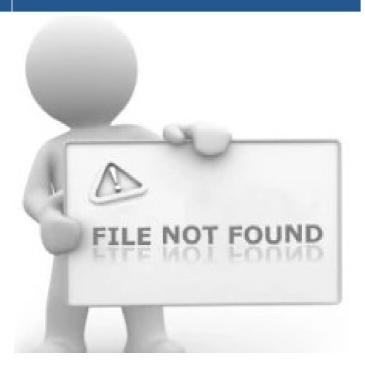
Before

Wear and tear

Pump stopped and Gland tightened. Monitored after starting the pump.

Renewal of gland is planned. During pre operation checks this should be included.

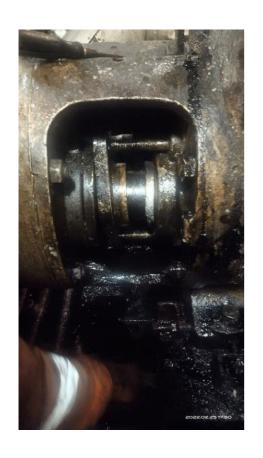
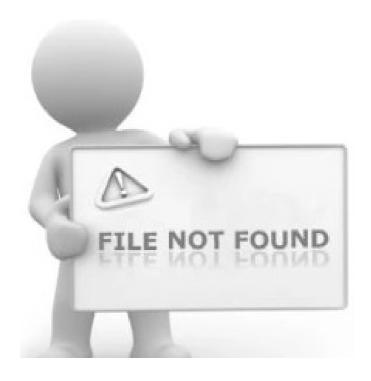
On	Ву	Follow Up	
28/Mar/2022	Nagaraju Rayani br/> Staff Code - 10431 - C/OFF	Gland renewed. Pics uplodaed after renewal. Working satisfactory	
03/Mar/2022	Nawin Khaware	Submit evidence/photographs once gland packing has been renewed and tested to be found working satisfactory.
