# Maritec Tanker Management Private Limited

## Near Miss Details

Vessel : Bahama Blue

Defect ID : 213

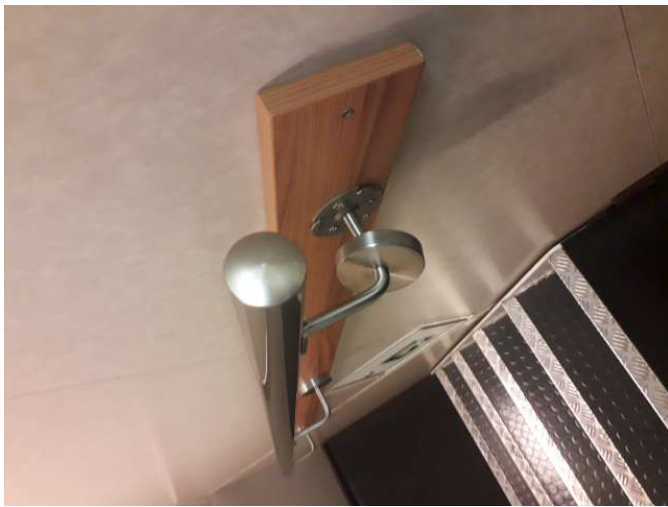
While getting off the accomodatin Stairs, Handrail was uprooted and nearly caused a 3rd Officer to fall. Luckily the incident was avoided due to proper maintaining 3 point contact on steps and ladder.

Heavy weather, All supporting equipments to be maintained in order.

Defective Ladders/ Stairs

Ship Movement

Engineers Notified, immediately got the railing fixed.

Regular accommodation rounds must be made by safety officer and Master to ensure all gears are maintained in good conditions. All crew members were advised to report immediately in case if such an important items are broken and not serving the purposes.

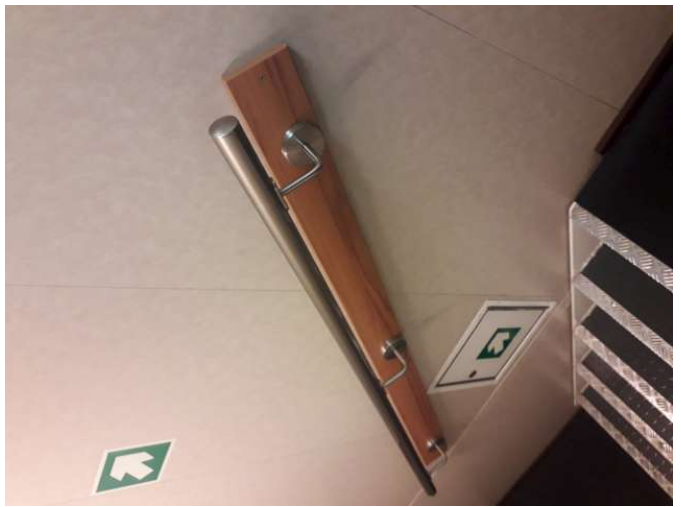
On	By	Follow Up	
31/May/2024	Vitaliy Klimenko   Staff Code - 10633 - MST	AWAITING OFFICE ACTION for this job has been changed to No	
31/May/2024	Vitaliy Klimenko   Staff Code - 10633 - MST	AWAITING OFFICE ACTION for this job has been changed to Yes	
31/May/2024	Alister Pascaol Lobo   Staff Code - 10582 - 3/OFF	Engineer notified and immediately got it firmly fixed back in place.
